HOME INSPECTION

## 45 Fernalroy Boulevard

Toronto, Ontario

RE: Report No. 99206  
45 Fernalroy Blvd  
Toronto, ON  
M8Z 3W2

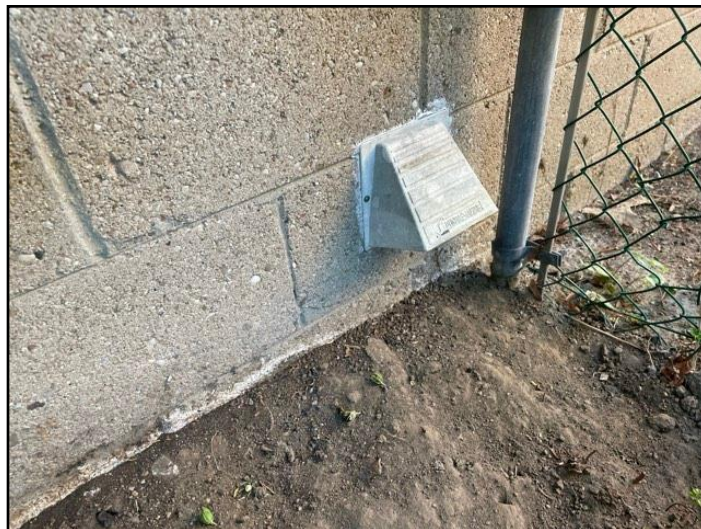
### WALLS \ Vent (fan, clothes dryer, etc.)

**Condition:** • Too close to grade

*Too close to grade*

**Task:** Improve/keep area, clear of accumulated snow and debris

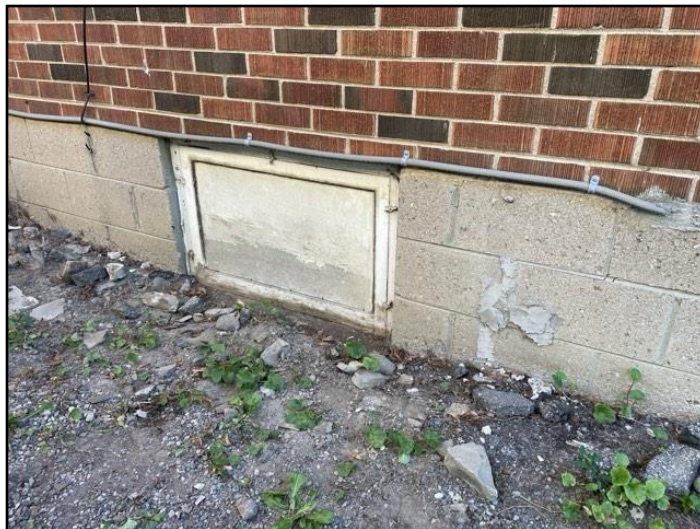
### EXTERIOR \ Window wells

**Condition:** • Missing

The clearance between the ground and the window sill should be improved.

*Missing*

As the window is boarded up consider removing it and patching the masonry wall

**Task:** Improve/Keep area clear of accumulated snow and debris.

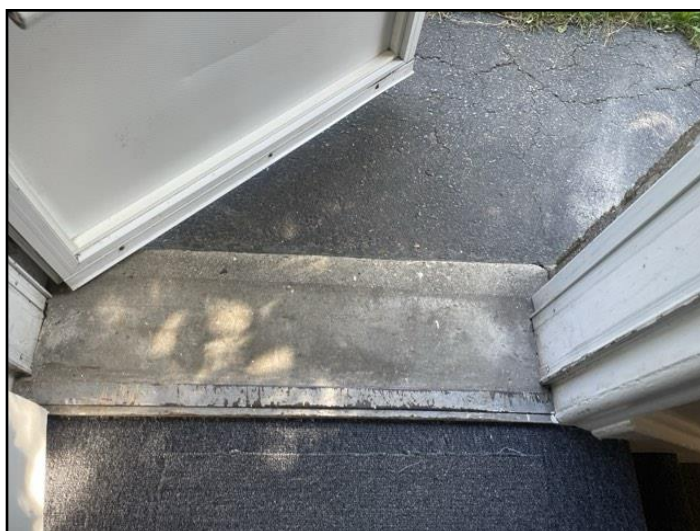
**Condition:** • Threshold - ineffective

*Threshold - ineffective*

**Task:** Keep the area clear of accumulated snow and debris

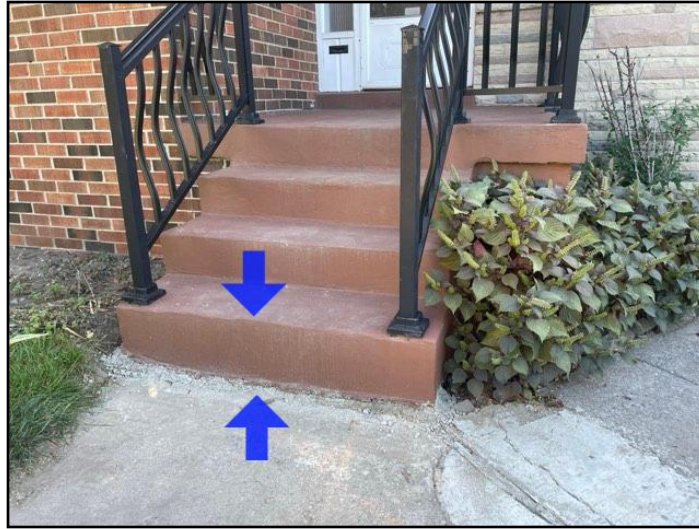
**Condition:** • Stair rise too big or not uniform

*Stair rise too big or not uniform*

**Task:** Improve

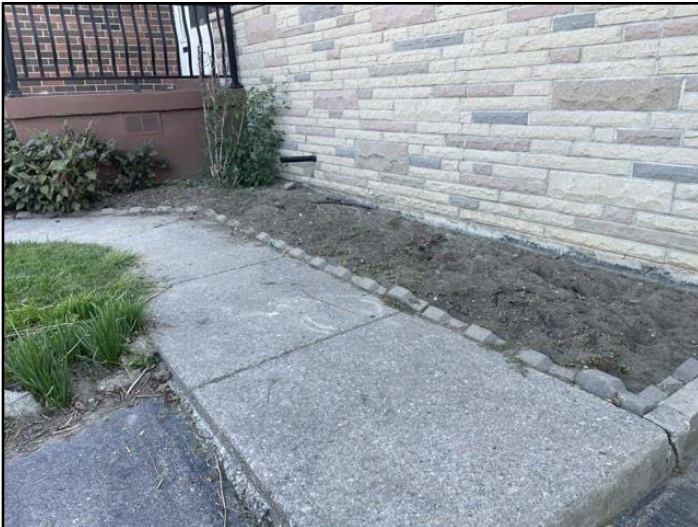
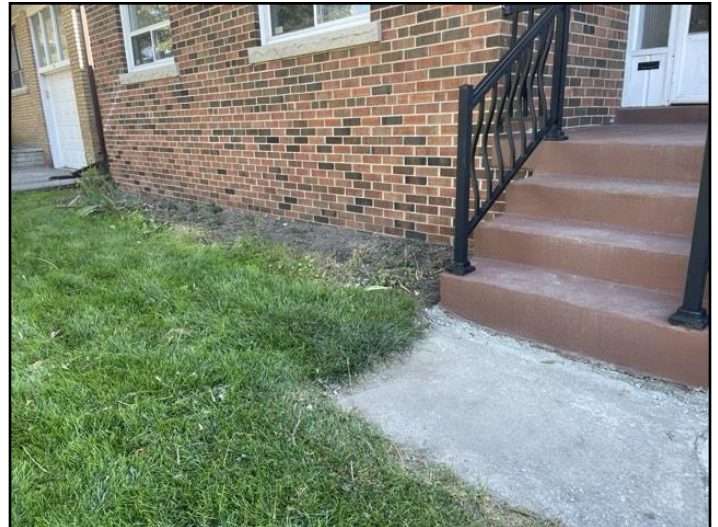
**Condition:** • Raised gardens against the house

Raised gardens against the home increase the risk of moisture problems in the basement, especially if they are watered regularly.

*Raised gardens against the house*

**Task:** Monitor and re-arrange if necessary.

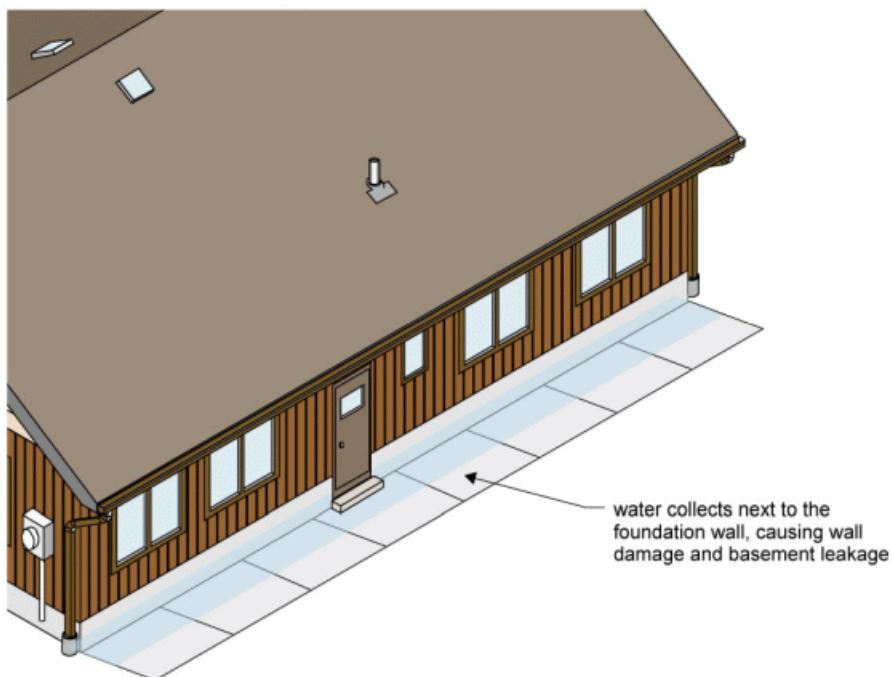
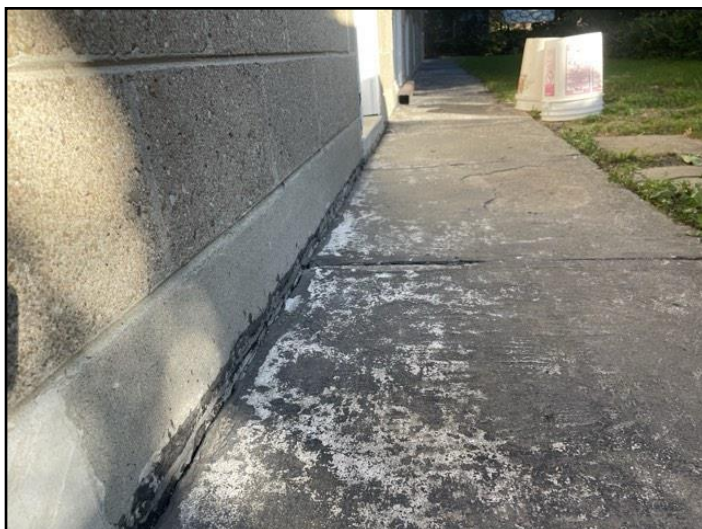
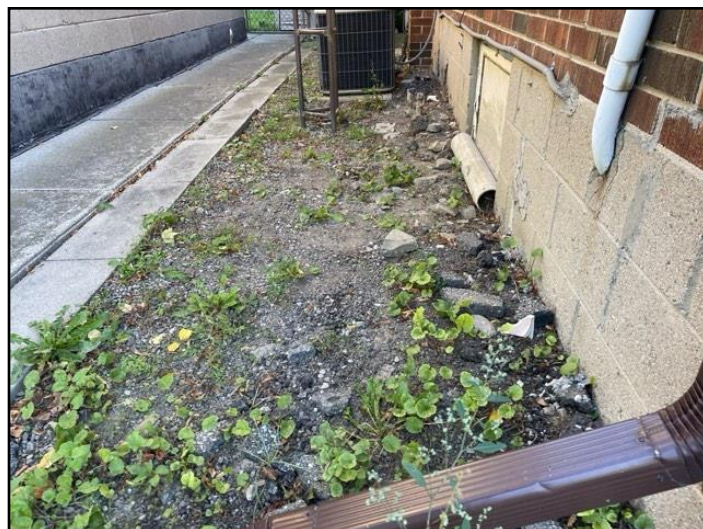
**Condition:** • Improper slope or drainage

Minor settlement on right side of garage and and left side of house

**Walk/patio sloping towards house**

*Improper slope or drainage*

**Task:** Improve

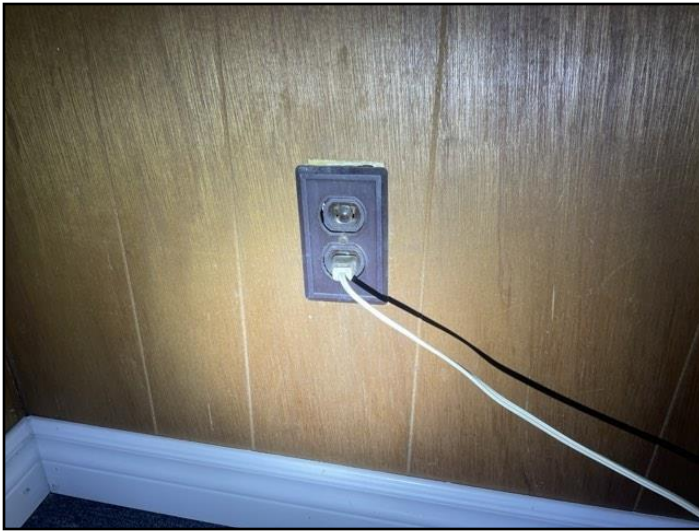
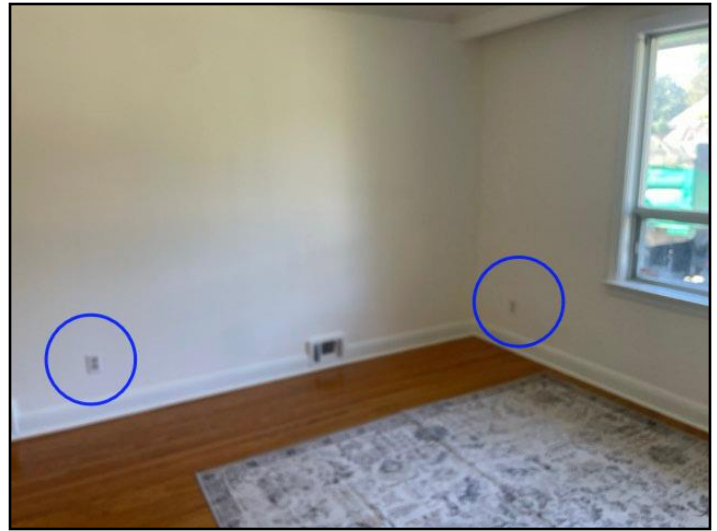
**Condition:** • Ungrounded

Ungrounded

**Task:** Improve

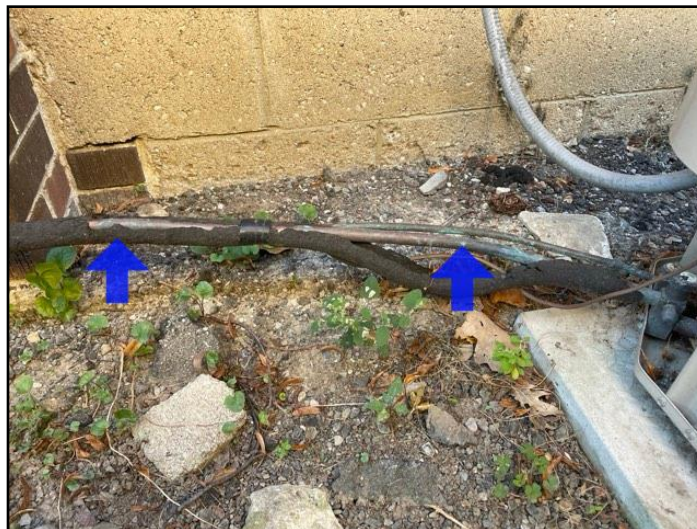
**Condition:** • Insulation - missing

*Insulation - missing*

**Task:** Replace insulation

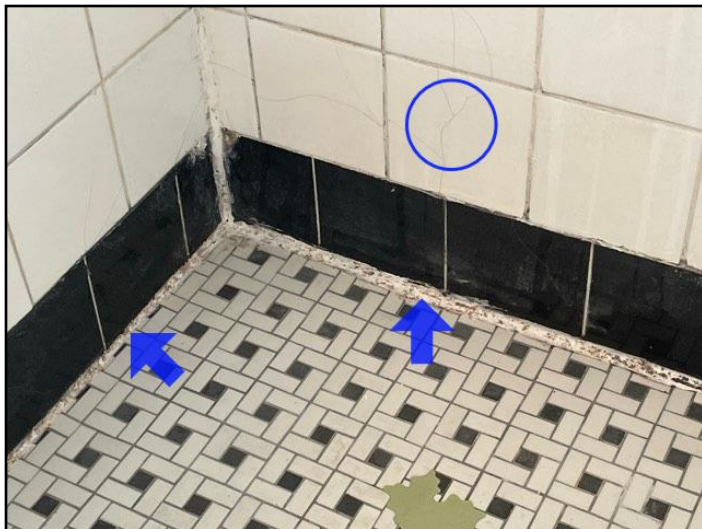
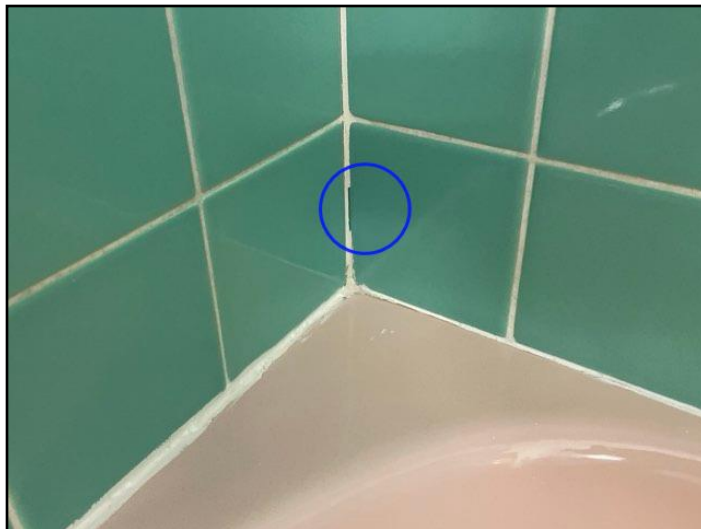
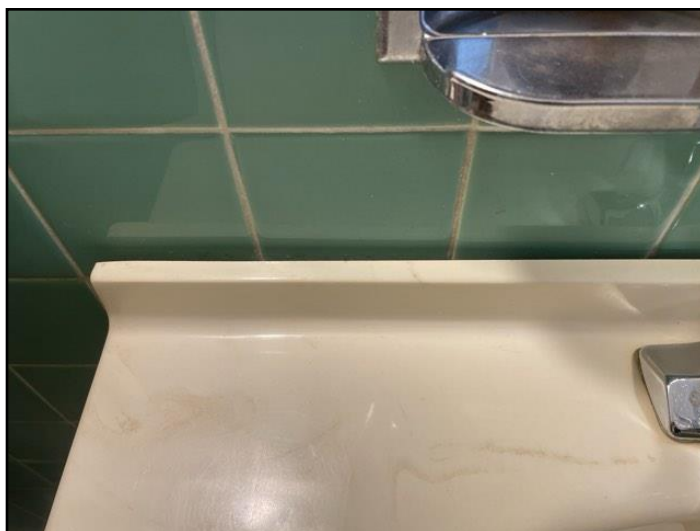
**Condition:** • Caulking loose, missing or deteriorated

*Caulking deteriorated-Crack tile - Basement*

*Caulking missing - second floor*

**Task:** Replace caulking

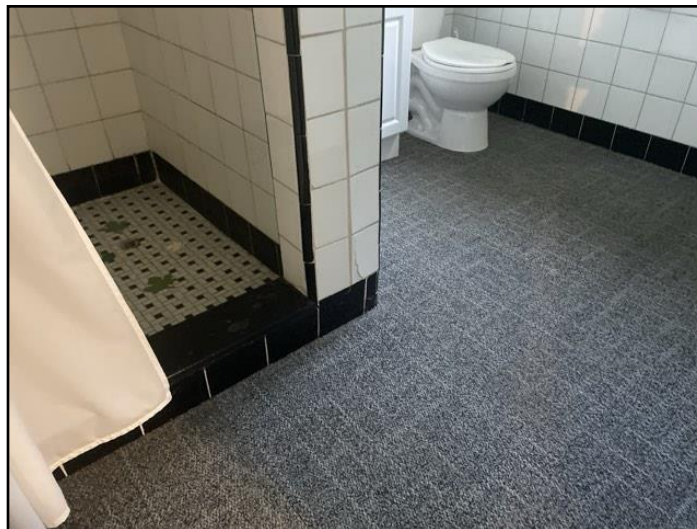
**Condition:** • Absorbent materials in wet areas

*Absorbent materials in wet areas*

**Task:** Replace carpet with a more appropriate material

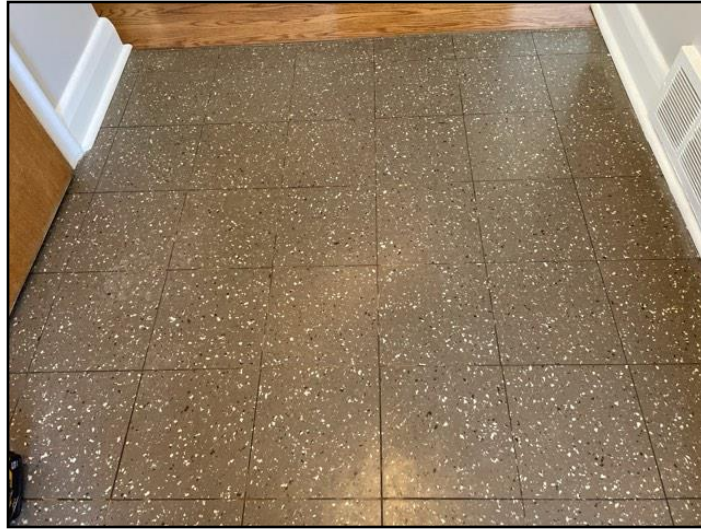
**Condition:** • Old 9"x 9" resilient floor tiles often contain asbestos. Further evaluation is recommended before removing these tiles.

Old 9" x 9" tiles

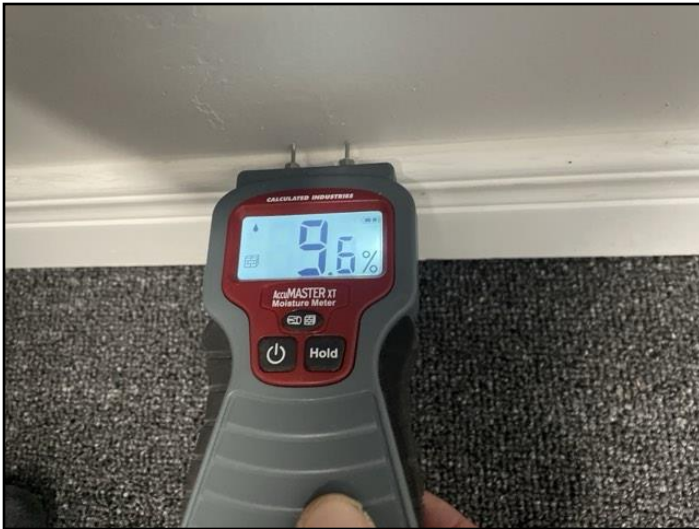
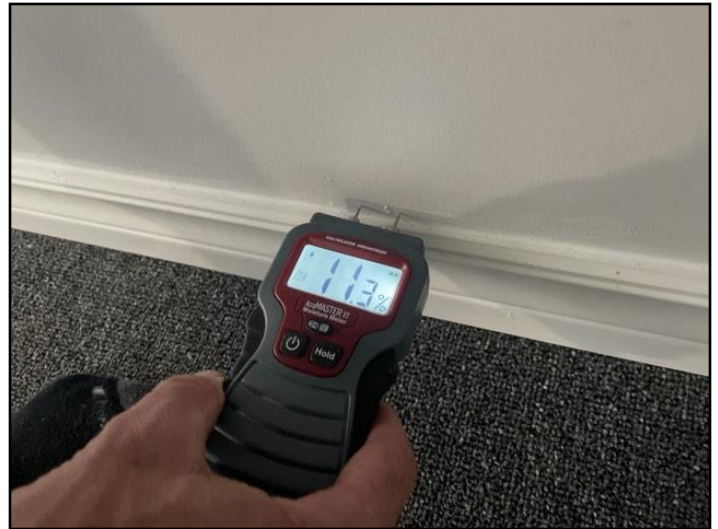
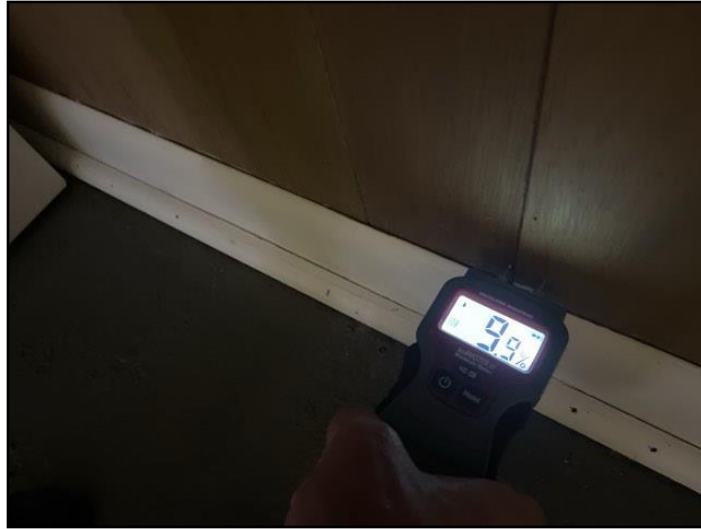
**Condition:** • Typical reading noted with meter during inspection.

Rear - Typical reading noted - Dry

Right - Typical reading noted - Dry

*Front - Typical reading noted - Dry*

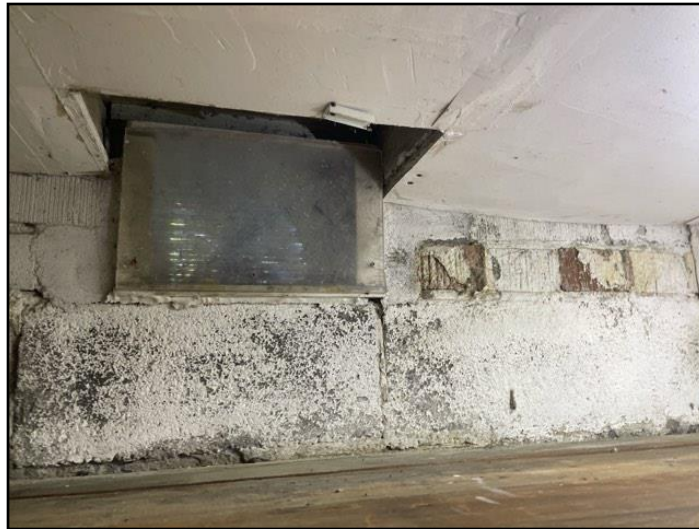
**Condition:** • Vent(s) missing/not visible

*Vent(s) missing/not visible*

If intended for use as interior storage: The exterior vent should be permanently sealed, and the space should be provided with adequate heating and/or air circulation so that it becomes part of the conditioned living area.

Recommend configuring the room to suit its intended use to help prevent temperature, moisture, and condensation-related issues.

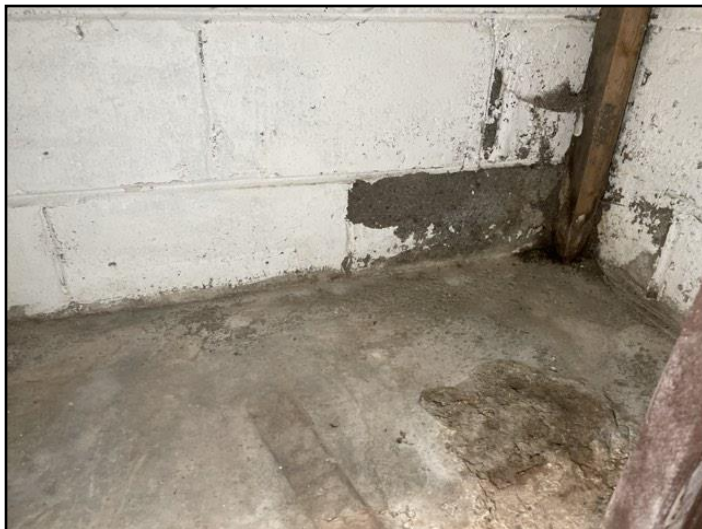
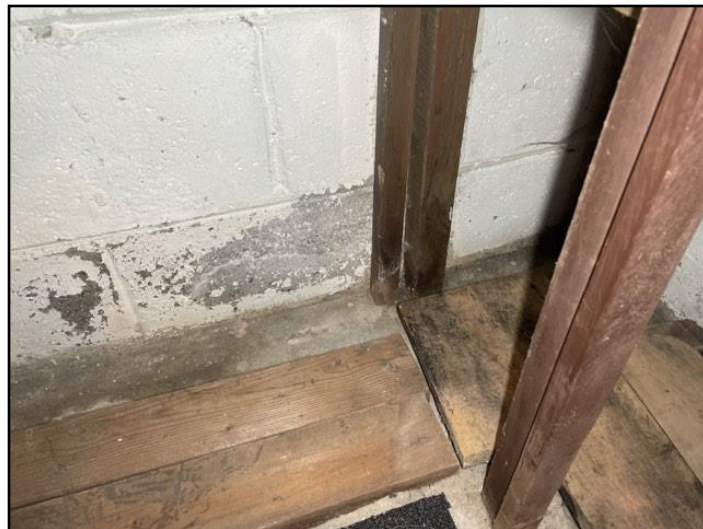
**Condition:** • Wood shelving in direct contact with the masonry floor and wall. Concrete and wood generally need an interface material to prevent moisture buildup and wicking.

wood with moisture stains

**Task:** Remove wood shelving
