HOME INSPECTION

## 61 Abilene Drive

Toronto, Ontario

RE: Report No. 99216  
61 Abilene Dr  
Toronto, ON  
M9A 2N1

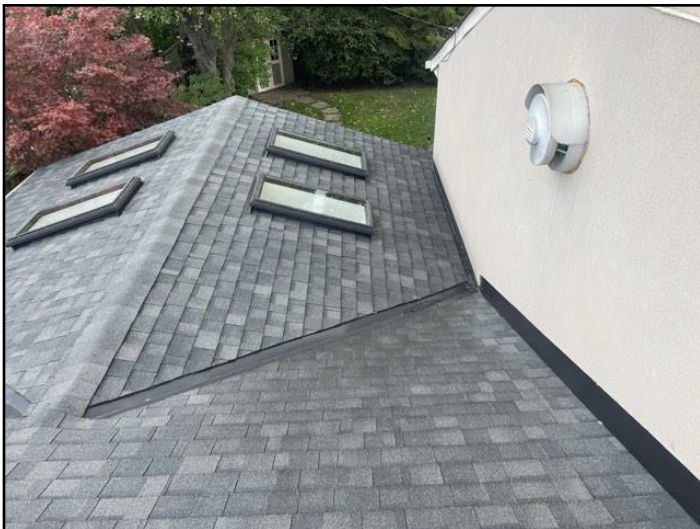
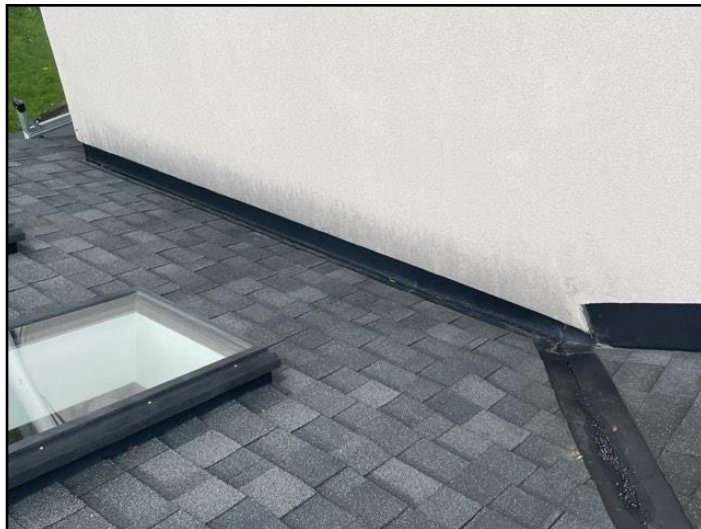
**Condition:** • Roof slopes directly into house, the roof may need to be reconfigured in this area.

**Task:** Improve

**Cost:** \$2000-\$4000 and up depends on approach

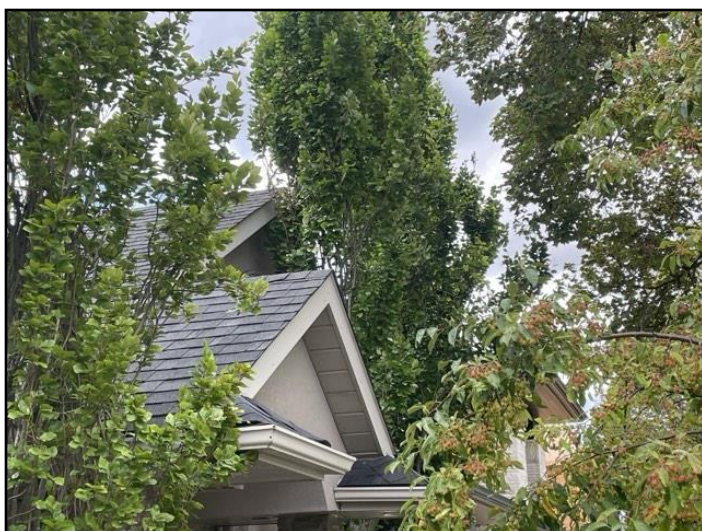
**Condition:** • Tree branches touching roof

*Tree branches touching roof*

**Task:** Trim tree branches

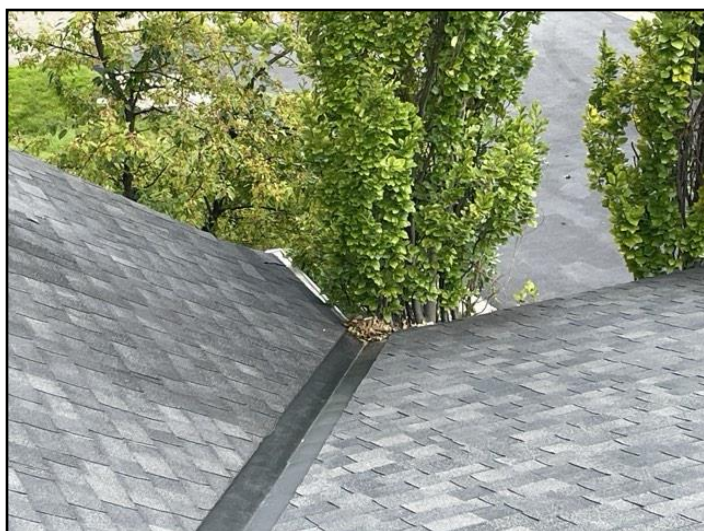
*Tree branches touching roof*

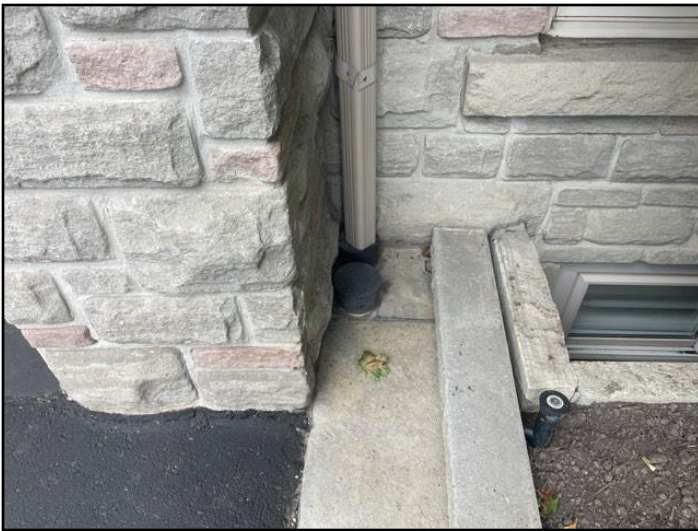
**Condition:** • Downspouts that discharge below grade may leak or be clogged, resulting in water in the basement or crawlspace.

*Discharge below grade*

**Task:** Ensure drains remain clear/Re-direct downspouts to discharge above grade at least 6 feet from home.

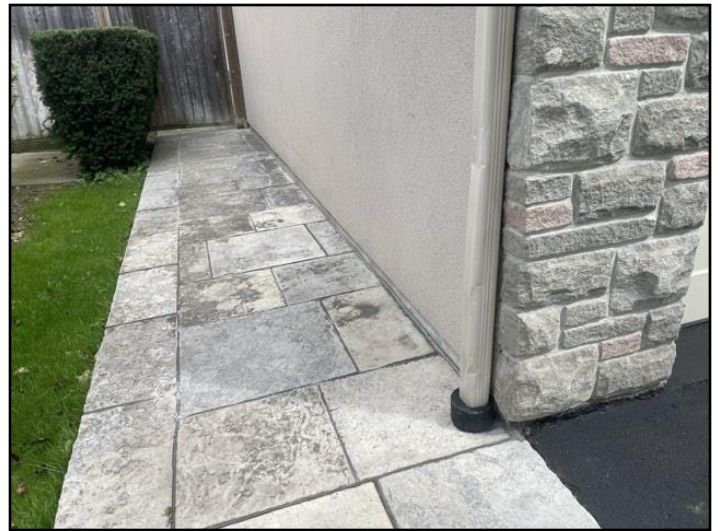
*Discharge below grade*

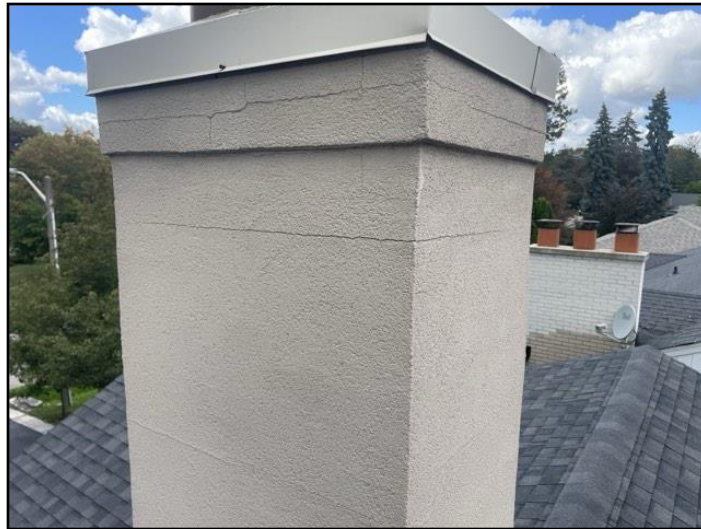
**Condition:** • Minor cracks

**Location:** Chimney

*Minor cracks*

**Task:** Repair/seal

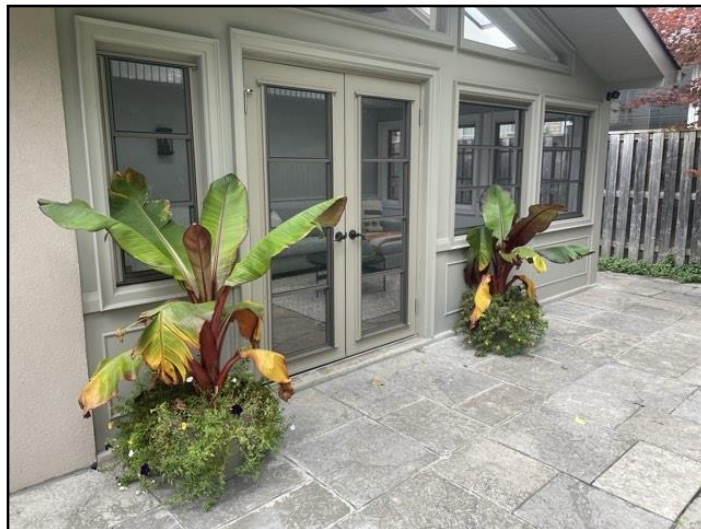
**Condition:** • Threshold - ineffective

**Location:** Rear main floor

*Threshold - ineffective*

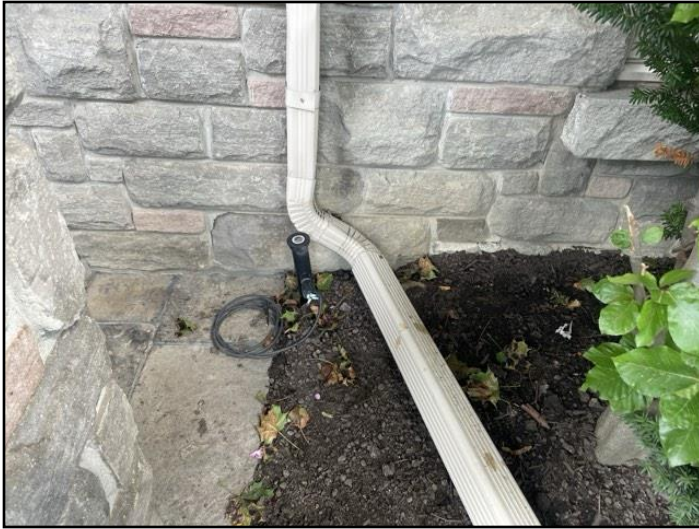
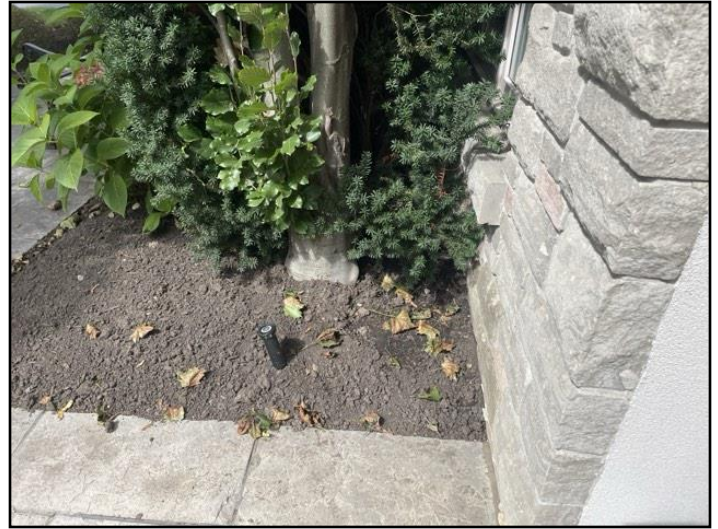
**Condition:** • Sprinkler-emitters too close to building

**Location:** Front

**Task:** Improve/remove

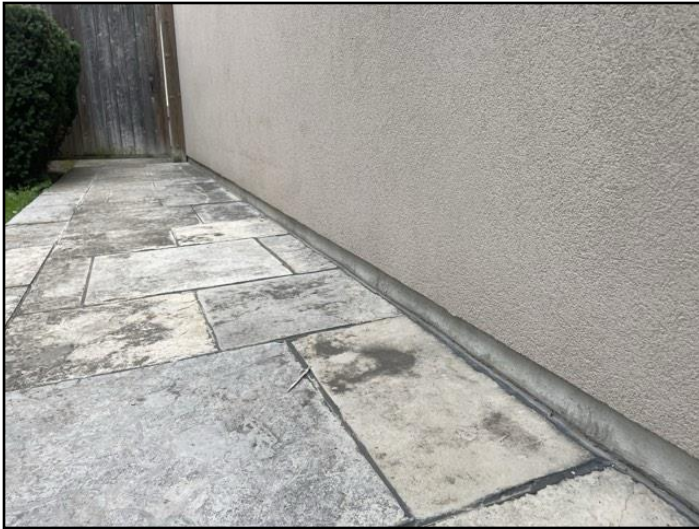
**Condition:** • Unsealed gap at building

**Location:** Left side

*Unsealed gap at building*

**Task:** Seal

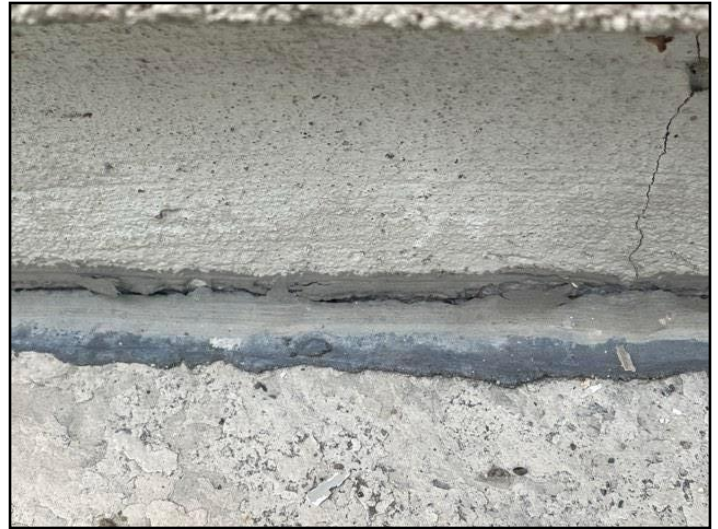
*Unsealed gap at building*

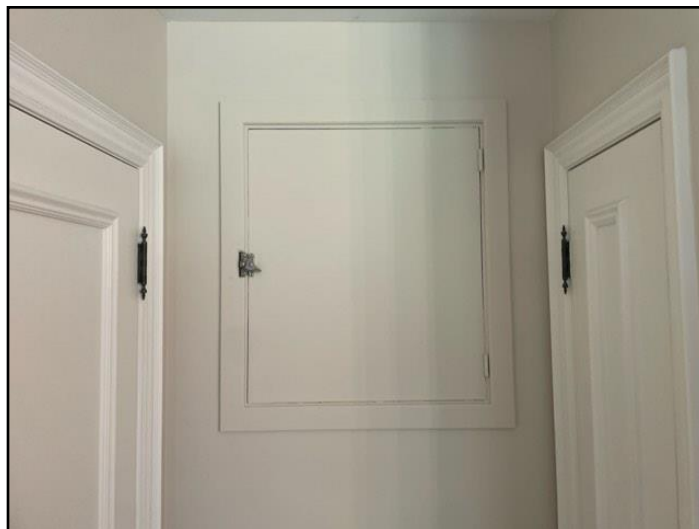
**Condition:** • No access to attic

Painted shut

*No access to attic*

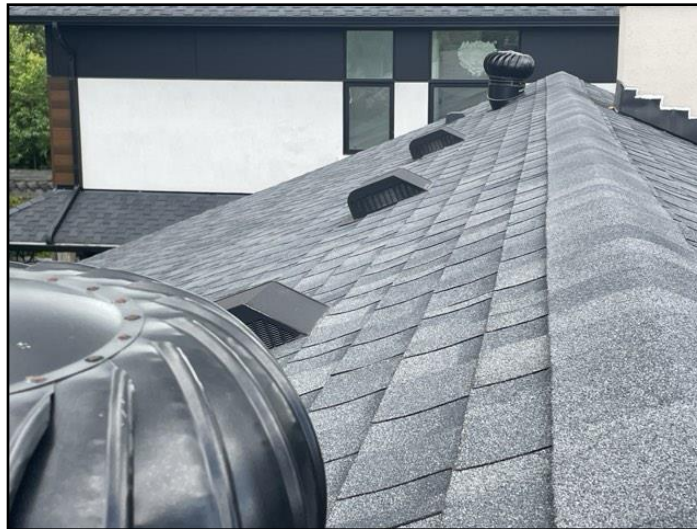
**Condition:** • Roof Vents (turbine type) - may cause low air pressure in the attic, increasing air leakage from the house. Warm moist house air leaking into attic may increase heating costs and moisture may condense, causing moisture problems in the attic.

*Roof vents (turbine type)*

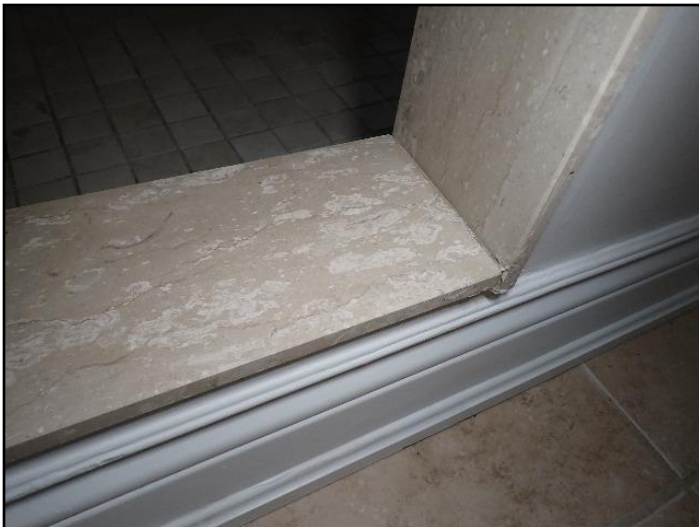
**Condition:** • Caulking loose, missing or deteriorated

*Caulking missing or deteriorated-Basement*

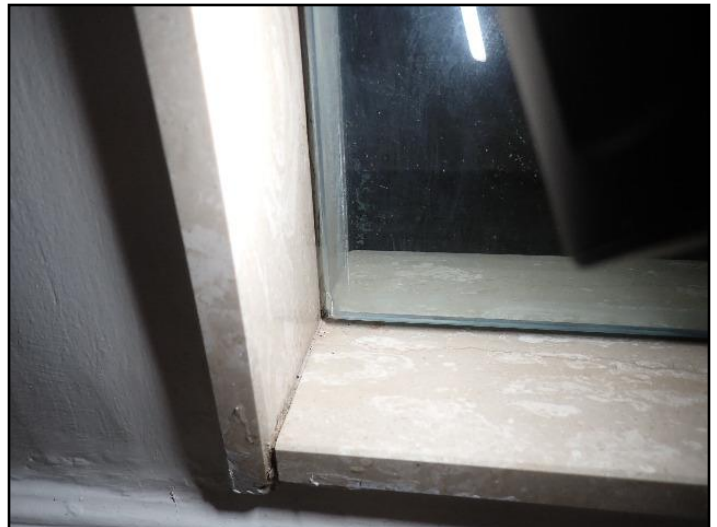
*Caulking, missing or deteriorated-basement*

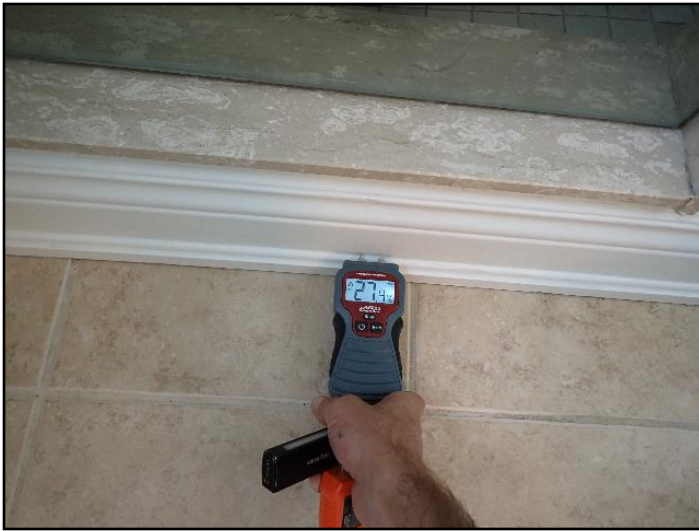
*Elevated moisture noted on the trim below*

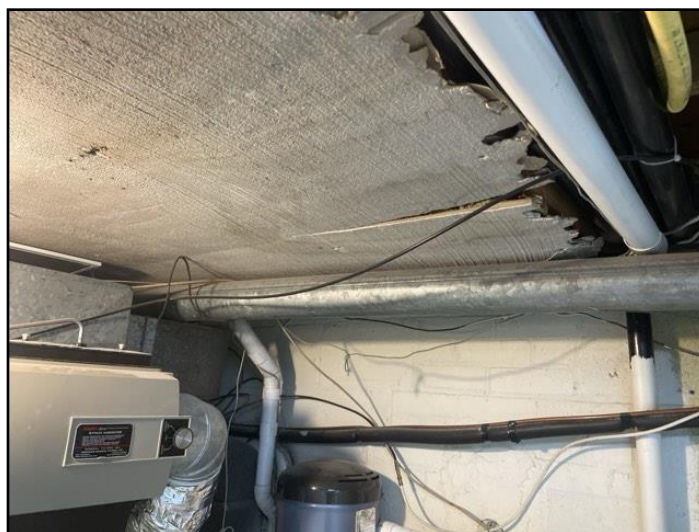
**Condition:** • Loose sections

*Loose sections*
