45 Fernalroy Blvd
Toronto, ON M8Z 3W2

INSPECTION DATE:
Monday, September 14, 2026

CARSONDUNLOP

RE: Report No. 99206, v.3
45 Fernalroy Blvd
Toronto, ON
M8Z 3W2

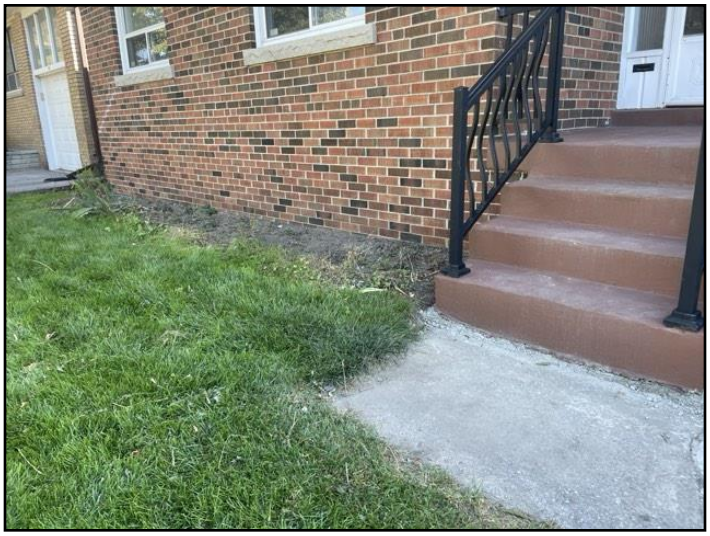
LANDSCAPING \ General notes

Condition: • Raised gardens against the house

Raised gardens against the home increase the risk of moisture problems in the basement, especially if they are watered regularly.

Raised gardens against the house

Task: Monitor and re-arrange if necessary.

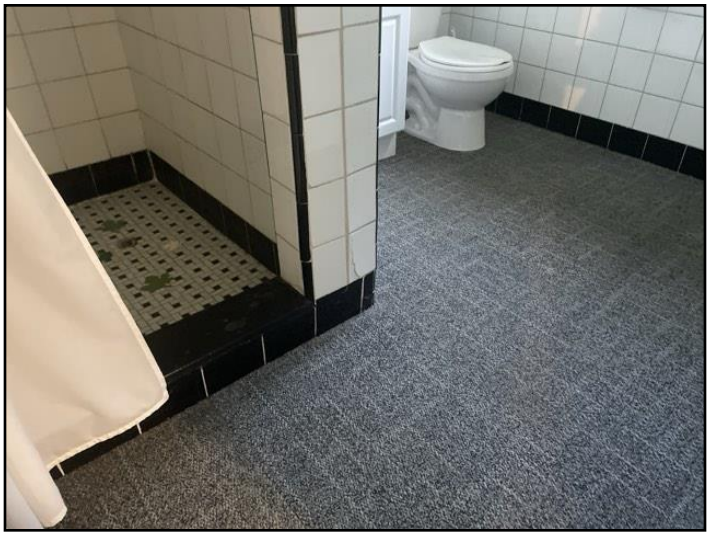
Condition: • Absorbent materials in wet areas

Location: Basement bathroom

Absorbent materials in wet areas

Task: Replace carpet with a more appropriate material
