HOME INSPECTION

28 Martin Grove Road

Your Inspection Report

RE: Report No. 99537
28 Martin Grove Rd
Toronto, ON
M9B 4J9

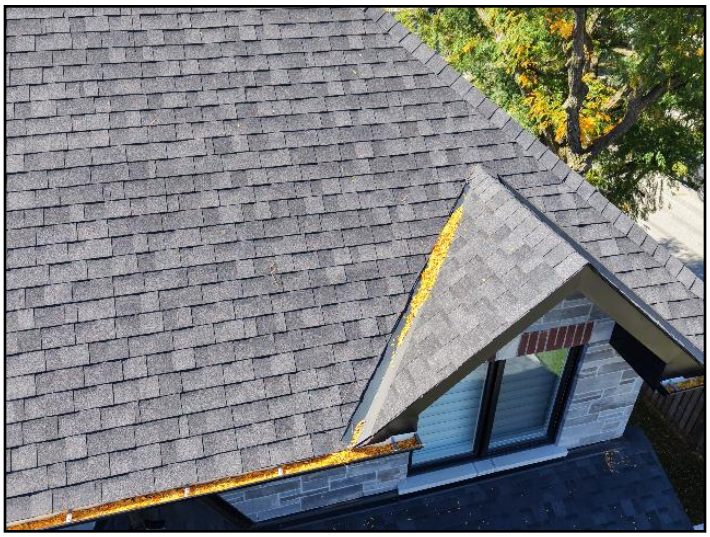
Condition: • Clogged

Clogged

Task: Clean

Time: Regularly

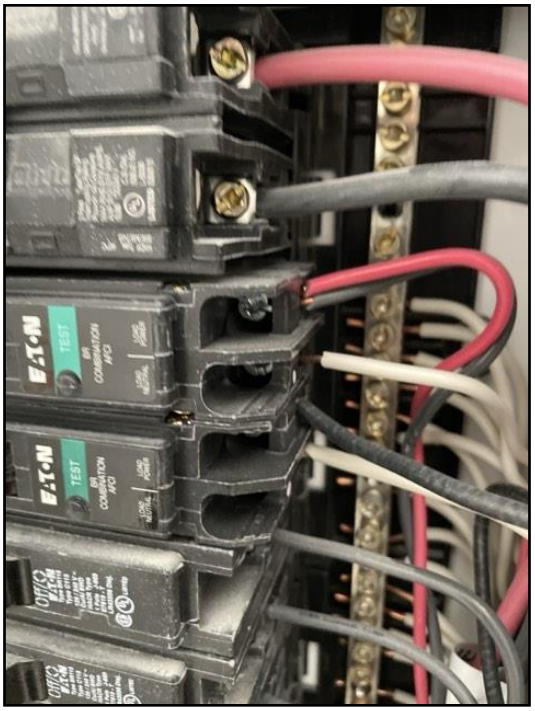
Condition: • Double taps

Double taps

Condition: • Wrong breaker. Single conductor in a bridged breaker.
Task: Further evaluation/improve - electrician
Time: As soon as possible
Cost: Minor
