HOME INSPECTION

8 Northolt Court

Toronto, Ontario

RE: Report No. 99698
8 Northolt Crt
Toronto, ON
M9A 3B1

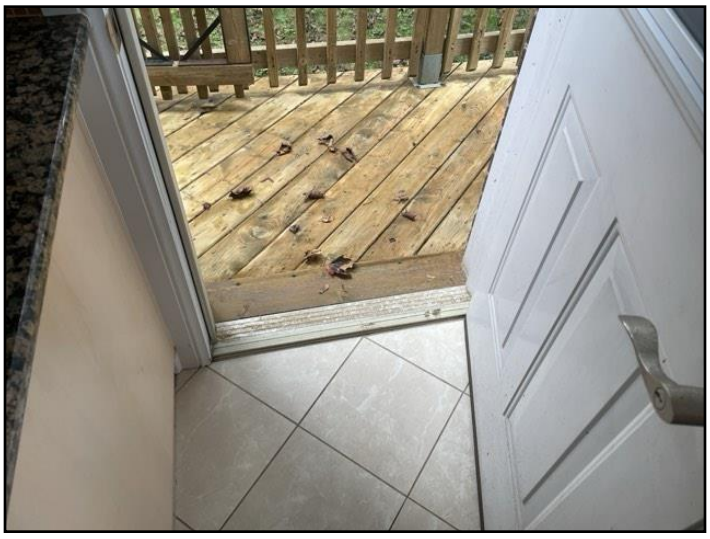
Condition: • Paint and caulking - deteriorated / missing

Example. Caulking deteriorated

Task: Remove loose material and re-apply paint and caulking

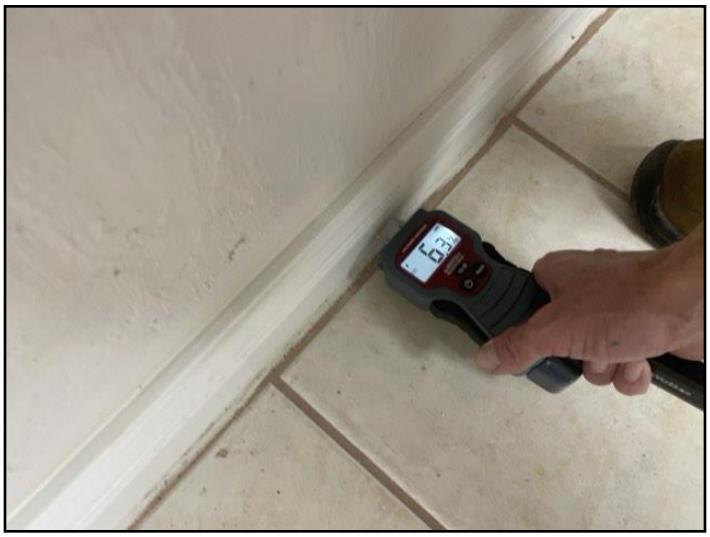
Location: Basement - Perimeter walls

Condition: • Typical reading noted with meter during inspection.

Typical reading noted-Dry
